# Fire Engineering®

## Construction Concerns: Combustible Cladding

*By Gregory Havel*

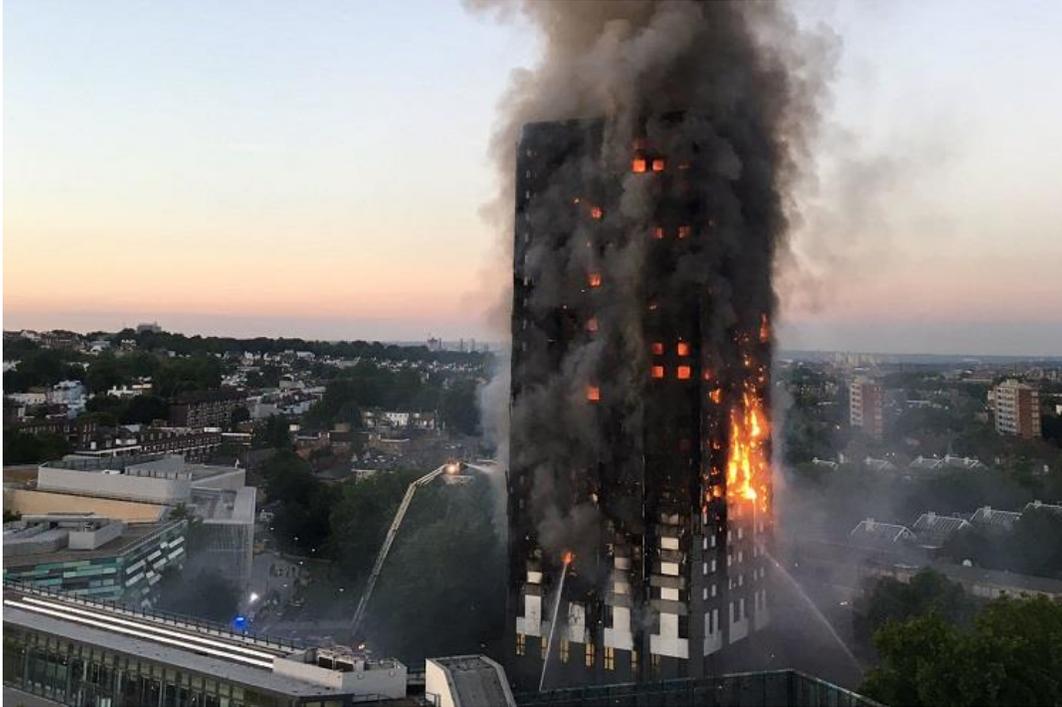
(1)

Photo 1 shows the burning building at 4:45 a.m. after nearly four hours of firefighting.

The fire started in a fourth-floor apartment just before 1:00 a.m. local time in a faulty refrigerator that was reported to have exploded. The fire then became a room contents fire, which self-ventilated by breaking a window, thus exposing the aluminum composite panels to enough heat for ignition. Once the ACP began to burn, the fire spread rapidly vertically and horizontally and broke into nearly all apartments through the windows.

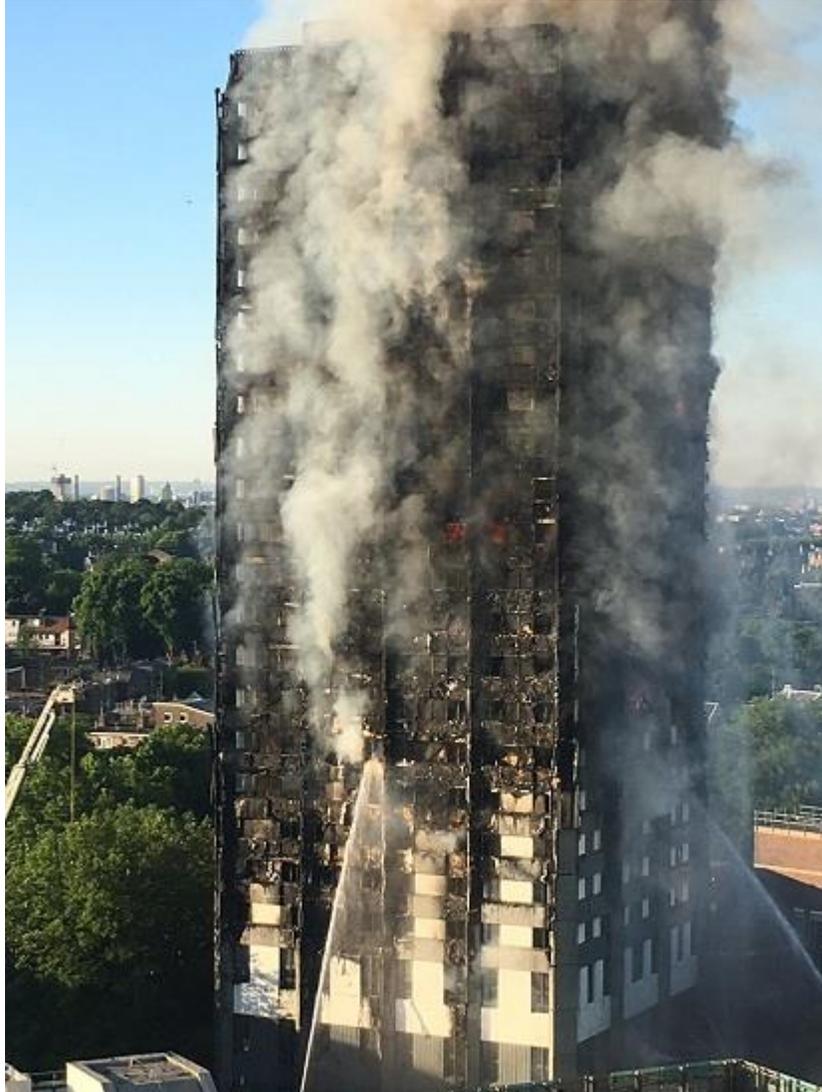
(2)

Photo 2 shows the building at 6:00 a.m. after nearly five hours of firefighting. Many injured people had received medical treatment and had been released, although others were still hospitalized.

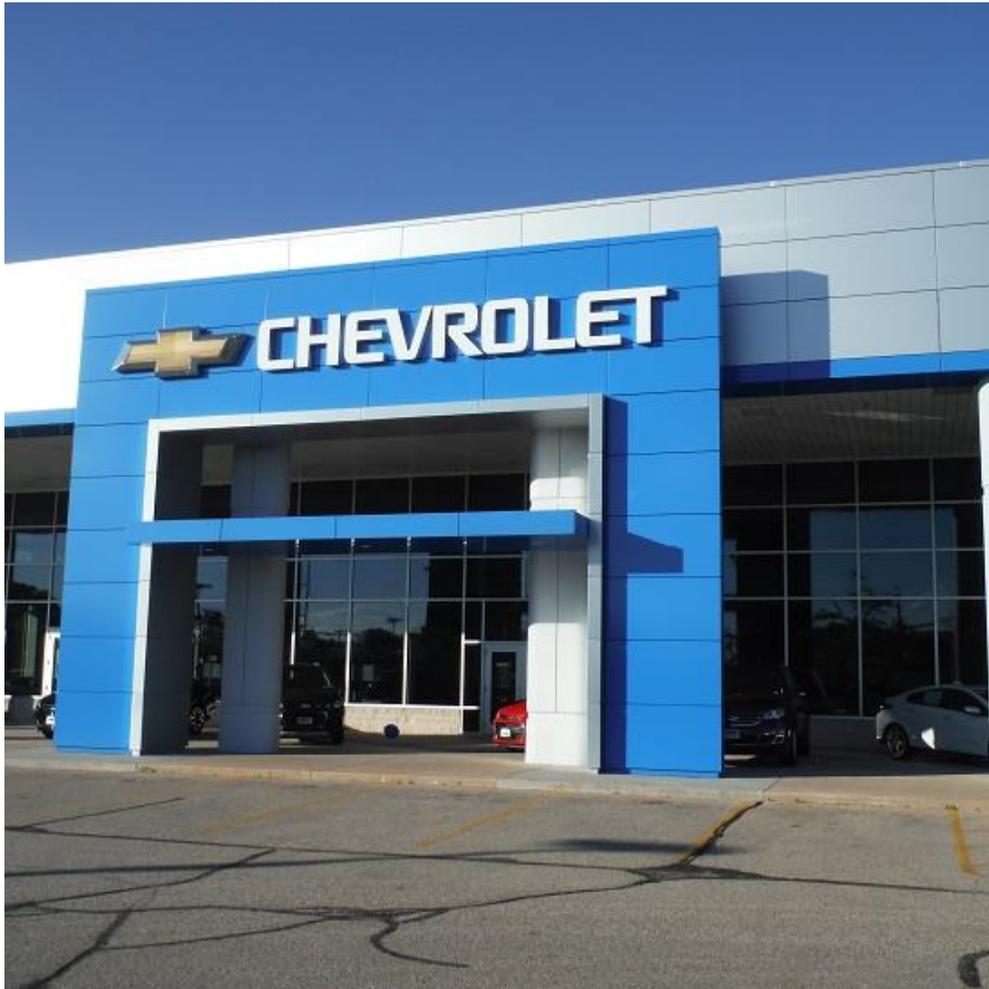
(3)

This type of ACP is widely used in North America as an attractive, weather-resistant exterior finish on convenience stores, low-rise buildings, and many automotive dealership manufacturers (photo 3). This material is available in durable finishes in many

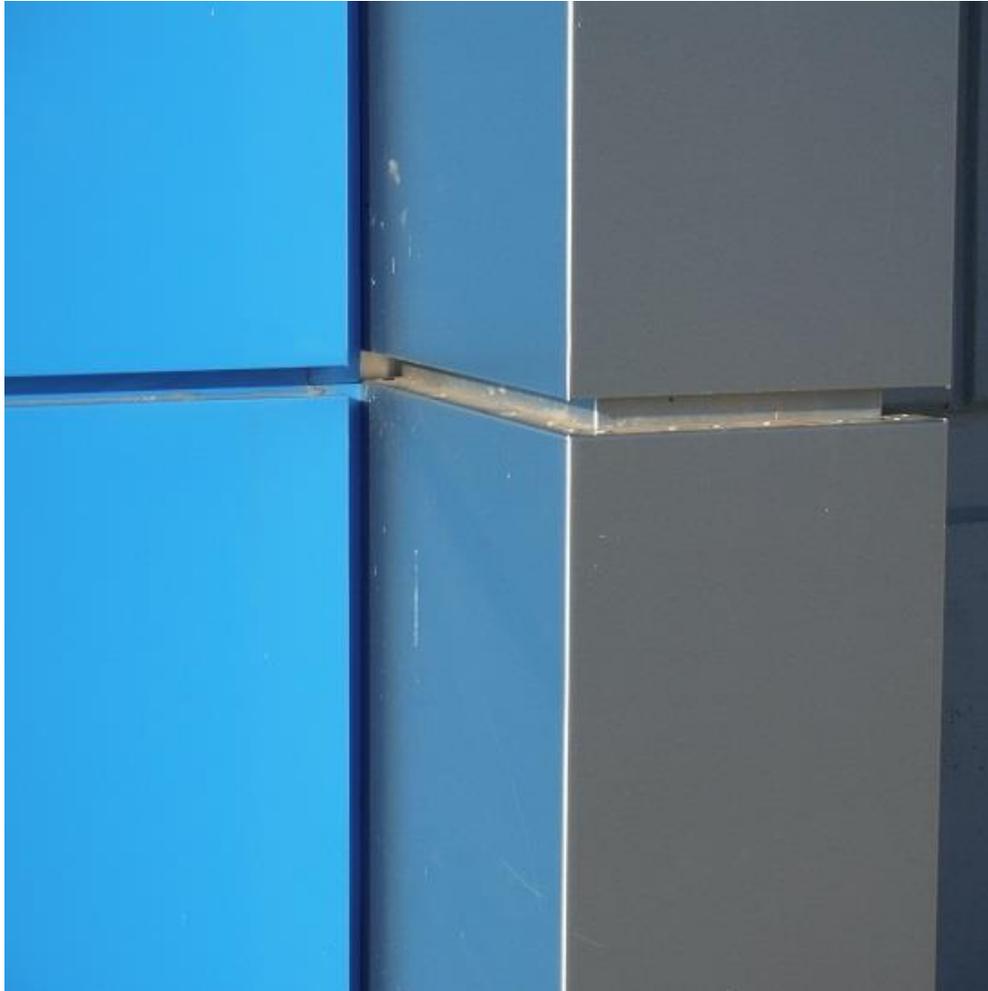
(4)

colors including mirror-polished metal, and can be formed into special shapes that reduce the number of seams and joints in the building's face (photo 4).

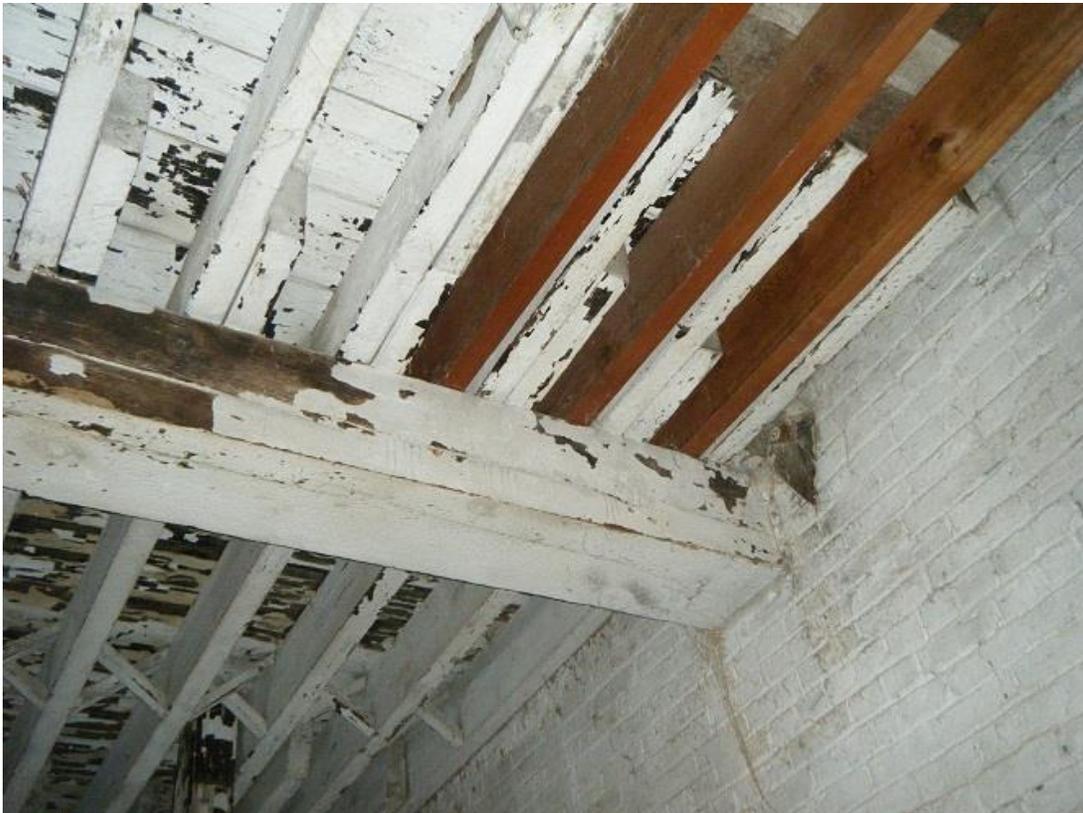
(5)

Some of the materials that are in use today such as masonry, concrete, and heavy timber with no concealed spaces (photo 5) would be easily recognized by fire protection engineers and fire chiefs from the late 19th century.

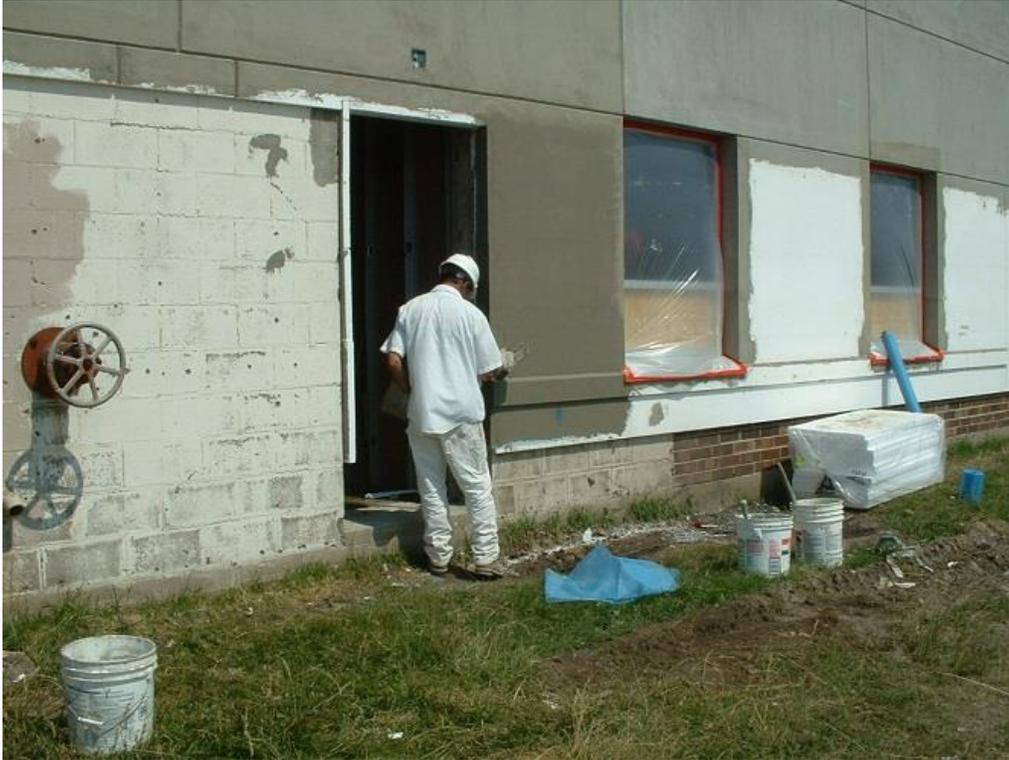
(6)

Other materials such as fire-retardant-treated plastics (photo 6); metal-plastic composites; and use of combustible materials in places where the building codes do not permit, recognize, and question as we should. These newer materials are creating a fire problem throughout the world, resulting in room-and-contents fires that expand beyond the capability of fire departments by the time they arrive.
